BTS2217 CERTIFICATE OF TEST: TR220727-1

An Assessment of the performance of the Aquamox Tape for Water Resistance over time when adhered to “aquamox tile backer board”

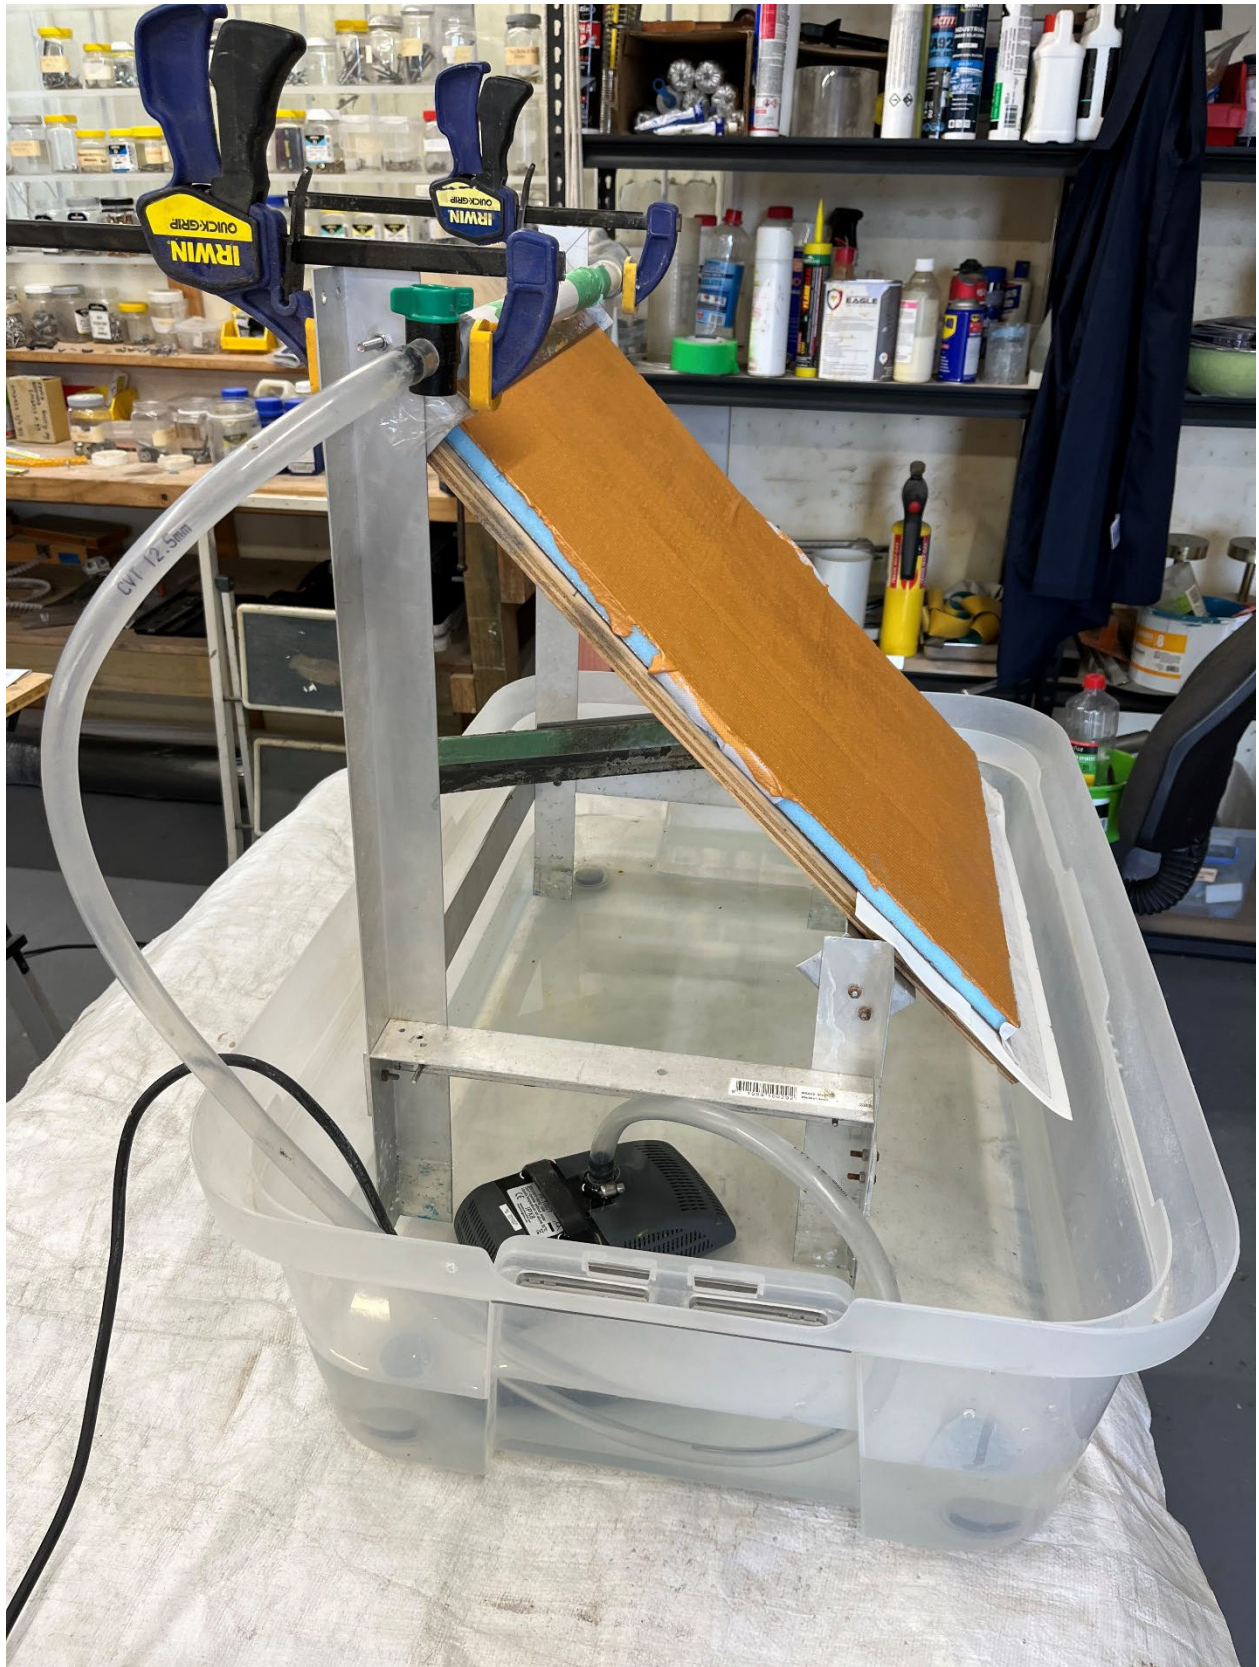
5.1 A sample comprising two sheets of the aquamox tile backer board, with the join sealed using the specified tape, then having a proprietary waterproofing system applied to the manufacturer's instructions, then left to cure, was constructed. Refer photo 1.

- 2.1 This method is based on BEAL Test Procedure TP148 Assessment of Water Resistance of Building Underlays. The slope of the test apparatus was set at 45° to the horizontal. The test specimen comprising the joint tape adhered to two samples of the aquamox tile backer board, were fixed to a plywood backing board which in turn was fixed to a jig designed for this type of test. A pump was used to deliver a constant stream of water over the surface of the building wrap, for a specified duration.
- 2.2 This test procedure has been developed in accordance with ISO 17007.
